# Safety Alert

## Change to surface conditions after Airfield de-icing media use.

25<sup>th</sup> January 2019

ASGrOps\_SA\_014

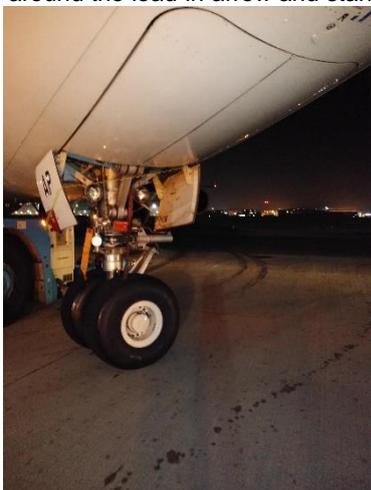
At 0515 on 24<sup>th</sup> January, an aircraft tug was towing an A340-600 to stand 582. The tug began its turn onto stand at or around the lead-in arrow and stand number paint marking. It is believed that as the tug commenced its turn towards the stand, it lost traction on the painted area of the taxiway surface and the tug rotated away from the aircraft. This resulted in the shearing of the tow bar pin and damage to the nose gear and tyres of the aircraft. The aircraft remained in the taxiway whilst a repair was effected to the nose-gear and then towed the remainder of the distance to stand.

This safety alert is issued to the Airside community as an awareness of an incident which occurred on the morning of 24<sup>th</sup> January involving an aircraft tug towing an aircraft. It is recommended that all airfield personnel, particularly manoeuvring area drivers and colleagues on foot on stand are reminded that paint markings may provide less friction than usual when liquid de-icing products have been applied to them, and take steps accordingly to minimise the risk of slipping.

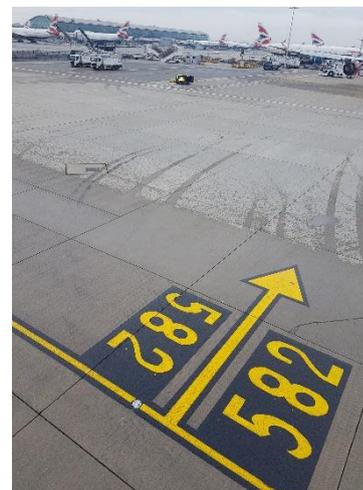
Overnight on 23<sup>rd</sup> January, Heathrow had carried out a routine anti-icing treatment of the runways and taxiways using a liquid anti-icing product. The product is viscous in nature, and when applied to airfield paint markings it can temporarily reduce the friction characteristics of the surface. This means that vehicles or personnel should take extra care when manoeuvring over large painted areas (such as stand lead in markings and aircraft stop marks on stands). Consider the speed of approach and avoid turning sharply on large paint marks where possible. Areas of taxiway which have been anti-iced will be identifiable as generally the centre portion of the taxiway will be a different colour to the edges, or to the stands – as shown in the image above ^.

Heathrow will promulgate to the community via the AOP (CDM) portal when the airfield has received an anti-icing treatment. Operating companies should pass this information to employees where appropriate.
