### Safety Alert

#### Ramp Agent Electrocuted by Frayed Cable

04 January 2023

ASGrOps\_SA\_044

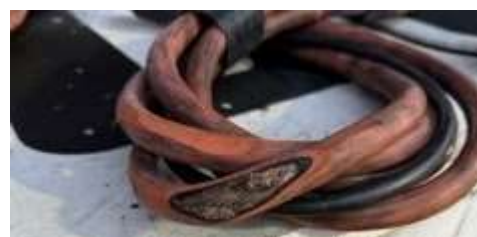
On 31<sup>st</sup> December 2022 a ramp agent was in the process of connecting a tug to an aircraft ready to be pushed back. They had plugged the GPU power cable into the aircraft, and when positioning the tug, were feeding the cable through their hands. The cable was frayed and had exposed wiring causing them to be electrocuted. The ramp agent was transported to hospital.

- Conduct pre-use checks of vehicles, including any wiring connected to the vehicle before using it
- Ensure GPU cables on tugs are stowed securely and cannot drag along the ground when the vehicle is in motion
- Fault any vehicles that are unserviceable to your company and do not use them, ensure they have a red tag so others' do not use them
- Report close calls and unsafe acts via your company's reporting channels and through the Airport Community App
