ASGrOps_SA_066

Safety Alert

Aircraft Ground Collision

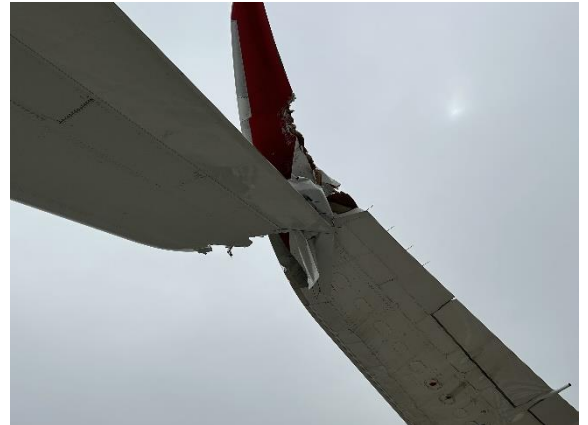
The purpose of this Safety Alert is to highlight an incident on 6th April in which two aircraft collided during a push back incident in Terminal 3.

A Boeing 787 was being pushed back from stand 323 into taxiway Golf using a 'dog-leg' manoeuvre, when the port-side wingtip collided with the starboard horizontal stabiliser of an Airbus A350 parked on the adjacent stand.

- If you are unsure about the safety of the pushback, then stop immediately and re-assess. Contact ATC if required.
- The use of wing-walkers should be considered for pushbacks or where the visibility of the tug driver may be obscured due to the nature of the manoeuvre.
- Headset operators should be positioned in such a manner that they are able to provide additional observation of any potential risks.
- Company processes, policies and training should be followed at all times.
- Hatched areas should always be clear of vehicles and equipment so as not to impede safe operations.
