# Airside Safety Catch Edition 7

Welcome to the 7th Edition of **Safety Catch**, from the Aerodrome Safety & Assurance Team.

Aerodrome Safety

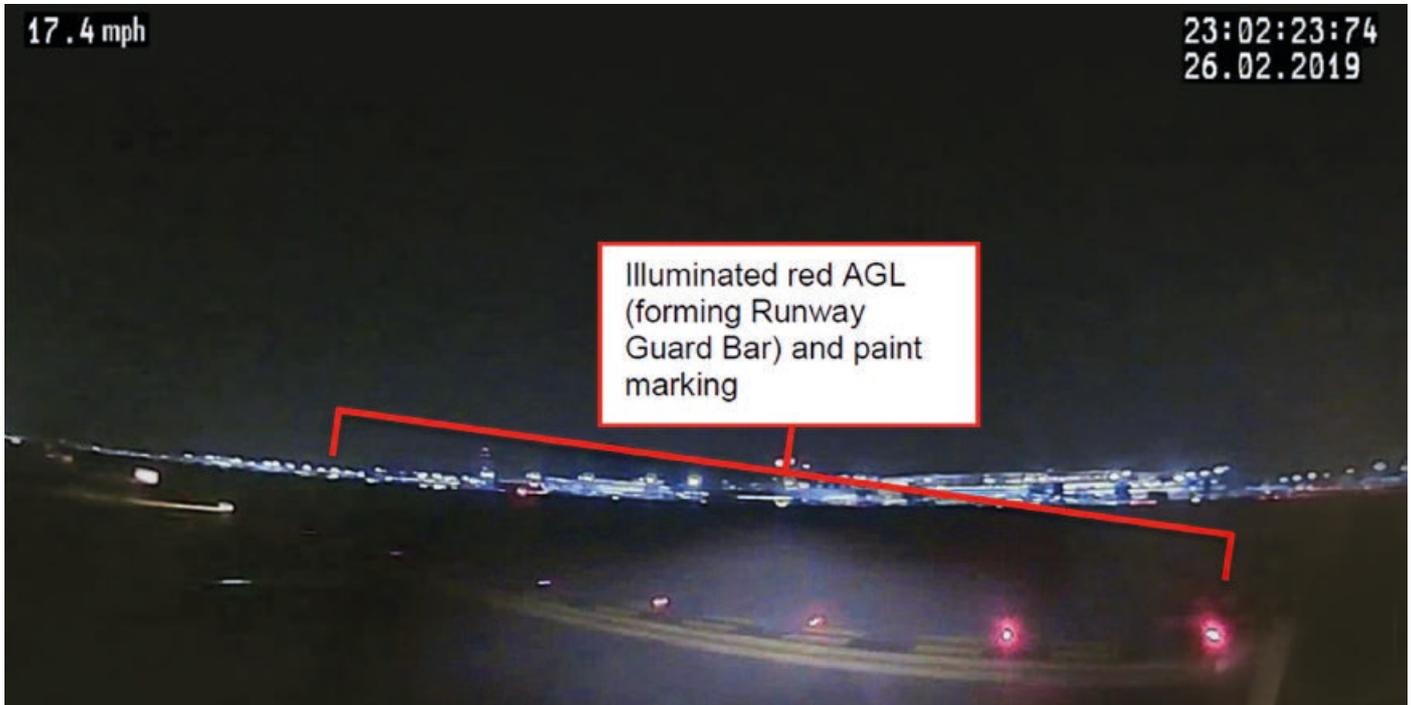
During the set-up of a temporary work site adjacent to Runway 09R, a contractor's vehicle entered at S4E without clearance. An A300-600F lining up on Runway 09R from S11 was in receipt of a take-off clearance but had not yet commenced its take-off run.

Dashcam footage from contractor's vehicle

The immediate cause of the runway incursion was a loss of situational awareness by the driver. The root cause of the runway incursion was identified as an inconsistent approach to the set-up of work sites.

- ALOP Airside\_ASD-O\_ALOP\_011 (Management of Airfield Works) Version 3.0 (effective 16 May 2019) covers the procedure for work site set-up. Additional information is also published in ALOP Airside\_ASDO\_ALOP\_006 (Applying Restrictions and Closures) version 2.0 (effective 3 June 2019). The changes have been made following this event.

- The key learning point is that when a work site is adjacent to a live runway, before the contractor is led out to apply physical protection (cones), Bolton barriers should be placed across the full length of the Runway Guard Bar (RGB). These are to be lit in the hours of darkness.

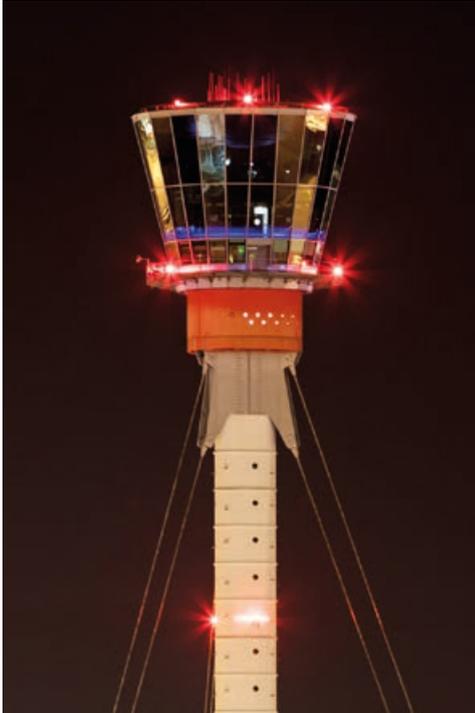
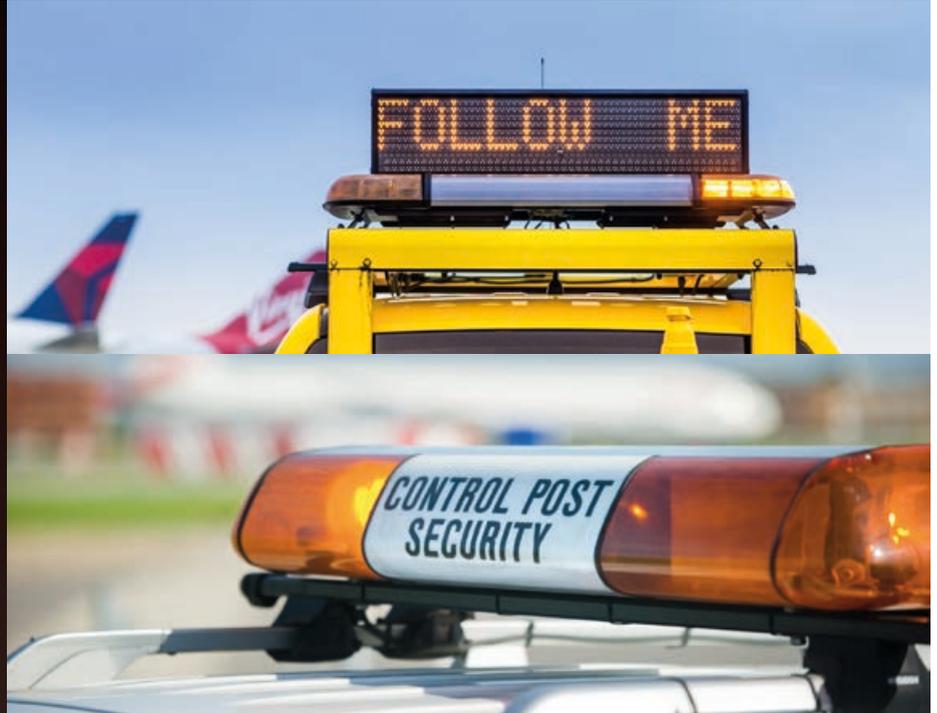
A Campus Security vehicle crossed Runway 09R/27L without ATC clearance. The Campus Security vehicle was responding to a breach of security (Code 97) by a recovery truck towing a ULD elevator. This was under a leader escort from Airfield Operations.

The illuminated 'Follow Me' board displayed by the Leader vehicle was a factor in the Security Patroller's decision to follow the vehicles onto the runway. It was interpreted as the provision of a leader escort/convoy service, meaning it would be acceptable for her to join. Although aware of the unusual nature of the situation, and the Local Operating Instruction detailing an alternative course of action, the Security Patroller believed following 'the convoy' to be a safe and acceptable course of action. This was on the basis the vehicles had permission from ATC, the runway guard bar (red stop bar) had been suppressed, and there was a green AGL route across the runway.

- Always use the 'Follow Me' board on the vehicle and check all vehicles are following, particularly when crossing live runways. So far as possible, use the mirrors to check for other (unauthorised) vehicles that may have joined the convoy.

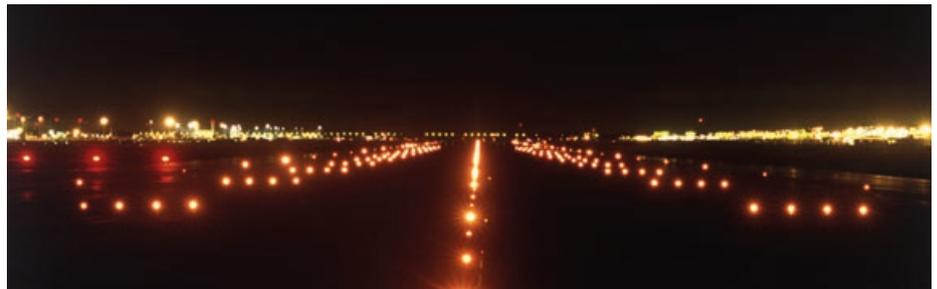
Lack of procedure for MALMS (Mobile Airfield Lighting Monitoring System) checks

This is an engineering task conducted by Airside Engineering checking the runway lighting is functioning correctly and involves several runs up and down the runway with the brilliancy turned up.

As the task is conducted on the live runway (overnight) and the engineers do not hold 'R' Airside Driving Permits, Airfield Operations are required to provide R/T cover. Reporters have explained it was unclear where the Airfield Operations vehicle should be positioned (i.e. on or off the runway). There was also confusion regarding runway guard bars (RGBs) in the event that the Airfield Operations vehicle was to change over due to the inability to suppress the RGB with the 'MALMS Test Mode' activated in the Tower.

An SWP (Standard Work Permit) has been issued which clarifies how the task should be conducted. It states that, "Both (engineering) operatives will wear specialist protection glasses to protect them from the brilliancy of the AGL – this will severely restrict their ability to see outside the vehicle and situational awareness of any obstacle or other vehicle on the runway. It is therefore critical that the runway surface remains sterile at all time; this includes the ASD vehicle that must be positioned outside of the runway shoulder (on a turnoff)." It goes on to say "If a handover is required between ASD Leaders to facilitate a break, this must be coordinated with the MALMS testing crew and ATC and the crossing of the RGB should take place between runs (data cannot be used if a run is interrupted)".

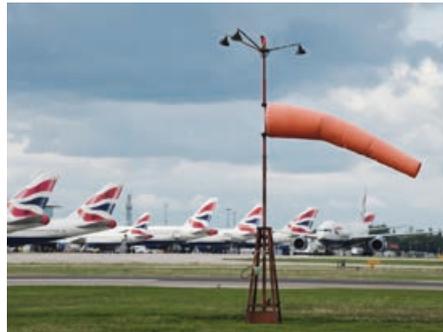
Windsleeves tangling up on a regular basis

Reporters pointed out that incorrect windspeed indication may be given to pilots by windsleeves that are unable to rotate fully. Untangling them could also present a health and safety hazard.

It was found that whilst the windsleeve themselves were subject to a routine inspection and replacement schedule, the poles were not listed as assets on Maximo. Subsequently they had not been subject to scheduled inspections and preventative maintenance. They have since been added to Maximo. Additionally, as the existing poles are approaching the end of their useful lifespan, replacements have been ordered and are due for installation before the end of the year.

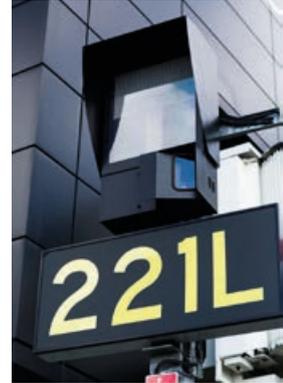
Aircraft entering stands without stand entry guidance activated

Reporters have pointed out the dangers associated with this and in some cases have spoken to the flight crew after the aircraft has parked to gain a better understanding. This information has been useful and helped us decide best to reduce the frequency of this.

Flight crews, particularly not-native English speaking, have not fully understood the AIP (Aeronautical Information Publication) text which states aircraft must not attempt to self-park and misinterpreted what was meant. To eliminate any potential for this, we have improved the AIP text to provide clarification that aircraft must not commit to the stand, but remain on the taxiway centreline in the event that stand entry guidance is not activated. Flight crews are also reminded to inform ATC and contact company to arrange activation. Airlines and commercial flight planning providers use the AIP information for their briefing packs which are reviewed by flight crews. This should help resolve the problem and create a safer operating environment.

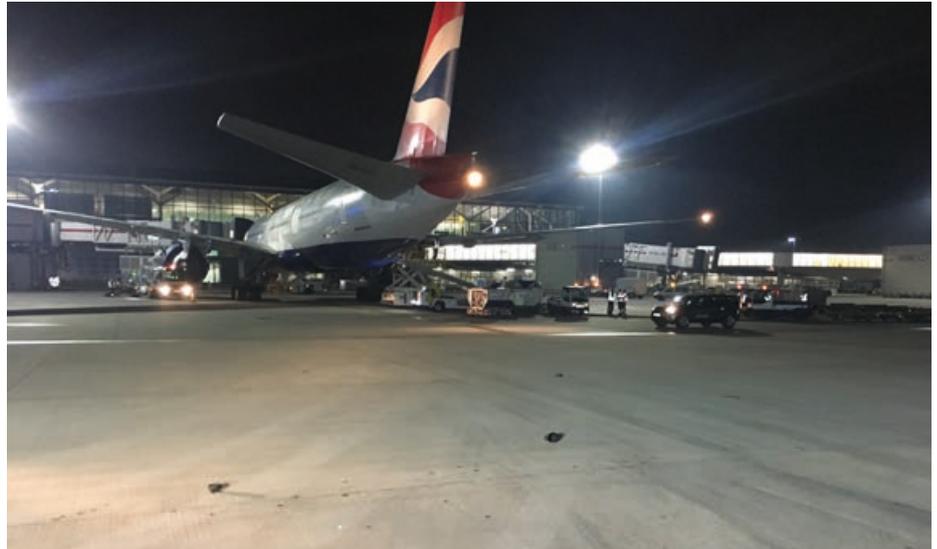
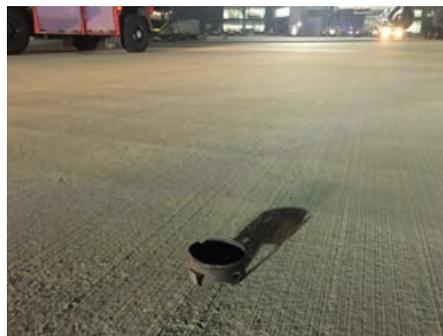
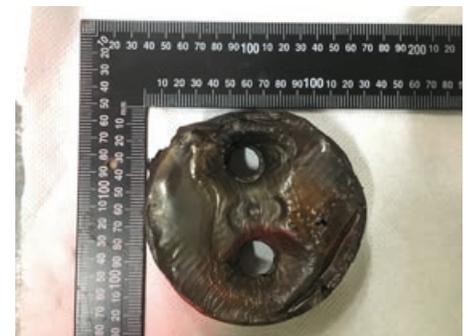
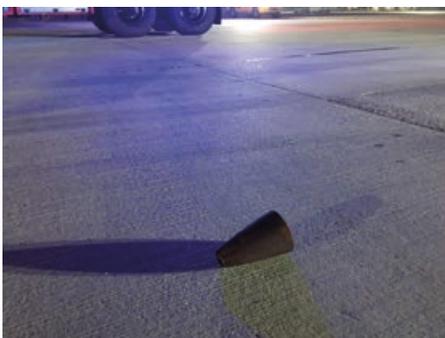
### **B777-300 Auxiliary Power Unit (APU) FOD**

Sparks and smoke were observed coming from the tailpipe of an inbound B777-300 followed by several items of FOD which were ejected on the taxiway surface. Airfield Operations were made aware and an Aircraft Ground Incident (AGI) initiated by ATC.

Airfield Operations attended the stand and temporarily closed the taxiway until the FOD was removed and the area made safe. Engineers and flight crew were spoken to which gathered useful information for the follow-up, including a review of the aircraft's tech log. The airline will be conducting an engineering investigation to determine the cause of the failure which is highly unusual.

This has led to follow-up with the airline to ensure that all ground staff are aware of the correct reporting process so that response from AFRS and other emergency services is not delayed. With such a detailed report submitted by Airfield Operations the follow-up process is made easier and a successful resolution more likely as a result.
