Monitoring the River Crane Water Quality and Ecology January - June 2017

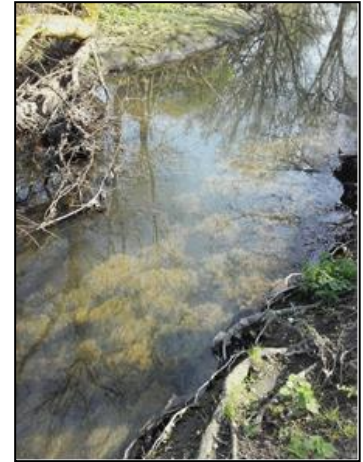
The image to the right shows sewage fungus in the River Crane on the 27th March 2017. The table below highlights the sewage fungus investigation results between January and June 2017.
